Contract #: 04-0120F4Cty: SF/ALA Rte: 80 PM: 13.2/13.9File #: 69.15**SOURCE INSPECTION REPORT****Resident Engineer:**Pursell, Gary**Address:** 333 Burma Road**City:** Oakland, CA 94607**Report No:** SIR-002117**Date Inspected:** 25-Apr-2010**Project Name:** SAS Superstructure**OSM Arrival Time:** 700**Prime Contractor:** American Bridge/Fluor Enterprises, a JV**OSM Departure Time:** 1900**Contractor:** Zhenhua Port Machinery Company, Ltd (ZPMC), Changxing Island **Location:** Shanghai, China**Quality Control Contact:** Don Walton**Quality Control Present:** Yes No**Material transfer:** Yes No N/A**Sampled Items:** Yes No N/A**Stock Transfer:** Yes No N/A**OK to Cut:** Yes No N/A**Rebar Test Witness:** Yes No N/A**Delayed/Cancelled:** Yes No N/A**Other:****Bridge No:** 34-0006**Component:** OBG Components**Bid Item:****Lot No:** B- 278**Summary of Items Observed:**

Inspection for Surface Preparation and/or Coating Application.

A joint three party inspection was performed by ZPMC QC's, ABF QA's and Caltrans QA for the OBG Internal Surface for Segment 9CE and Segment 9CW for Adhesion Test at Painting workshop no.1 and OBG assembly yard at Shanghai Zhenhua Port Machinery Co., Ltd., (

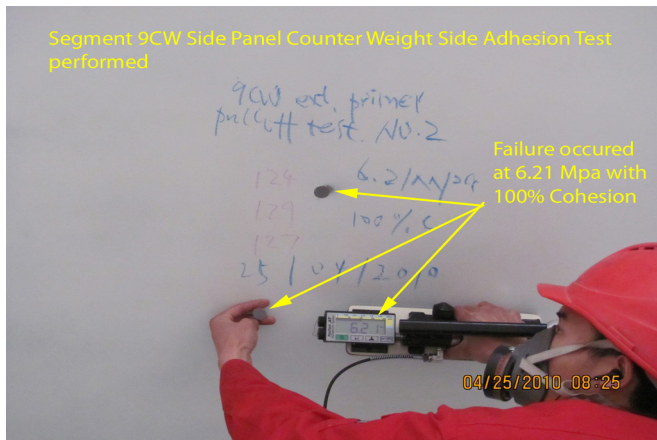
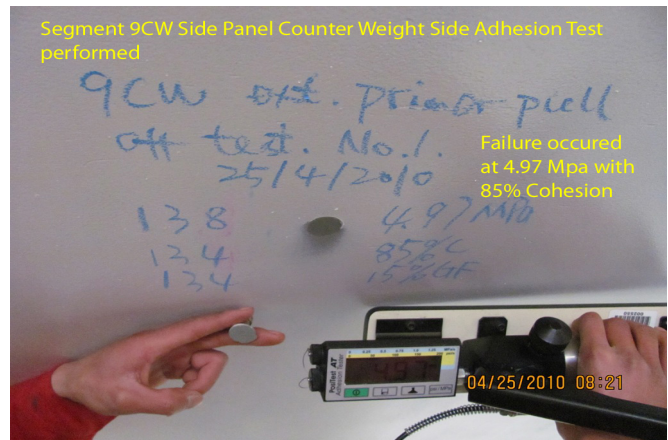
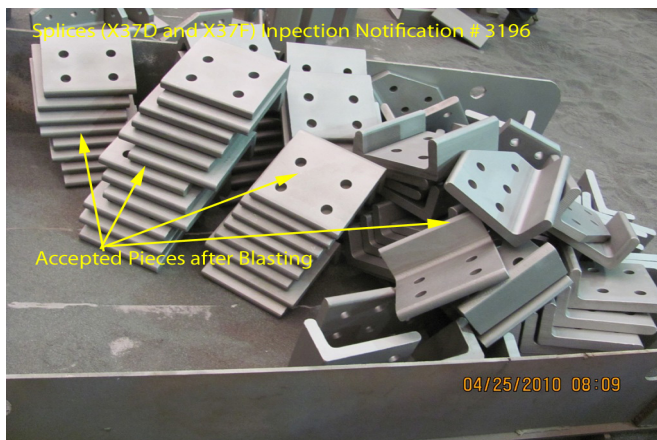
Inspection Conclusions: Segment 9CE Inspection was cancelled by ZPMC QC thus not inspected, Segment 9CW external side Adhesion test was accepted by ABF QA's and Adhesion result were recorded as 4.97 Mpa with 85% Cohesion Failure, 6.48 Mpa with 95% Cohesion Failure, 5.65 Mpa with 90% Cohesion Failure, 7.38 Mpa with 85% Cohesion Failure and 7.15 Mpa with 100% Cohesion Failure and Caltrans QA concurred with the ABF QA's Inspection. Please refer the pictures attached below for more comprehensive detail.
